X-RAY COMPUTED TOMOGRAPHY FOR FAILURE ANALYSIS

Richard H. Bossi
Alan R. Crews
Gary E. Georgeson

Boeing Defense & Space Group
P.O. Box 3999
Seattle, WA 98124

Interim Report for Period May 1991 to January 1992

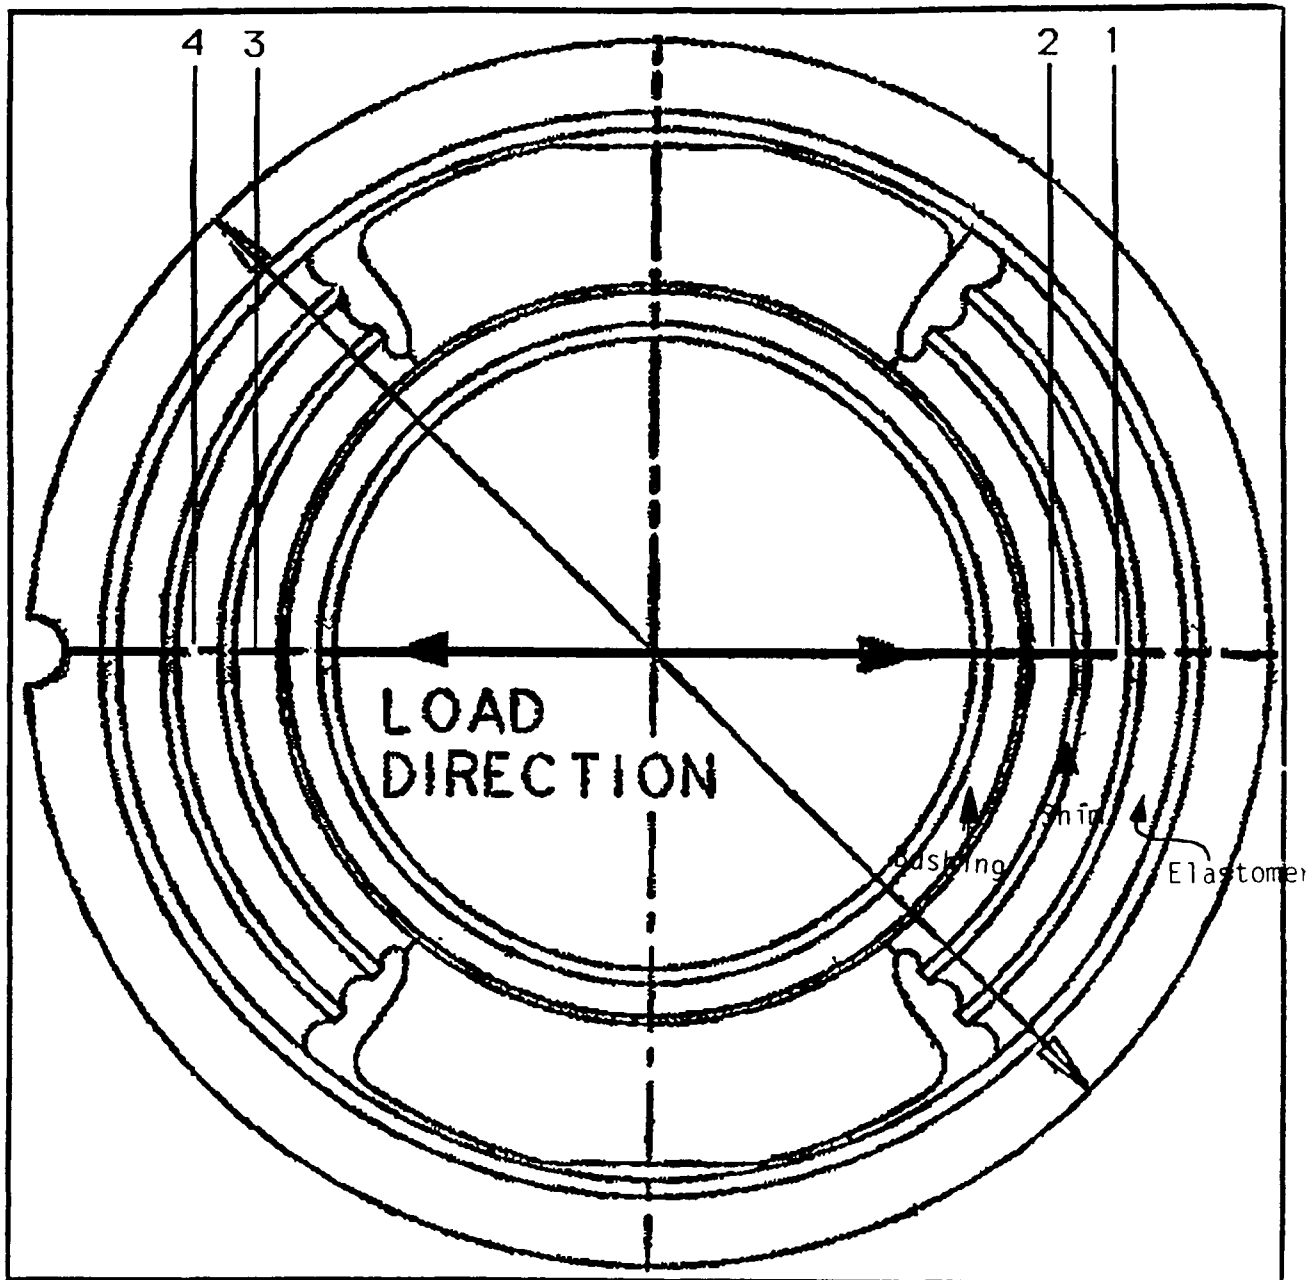
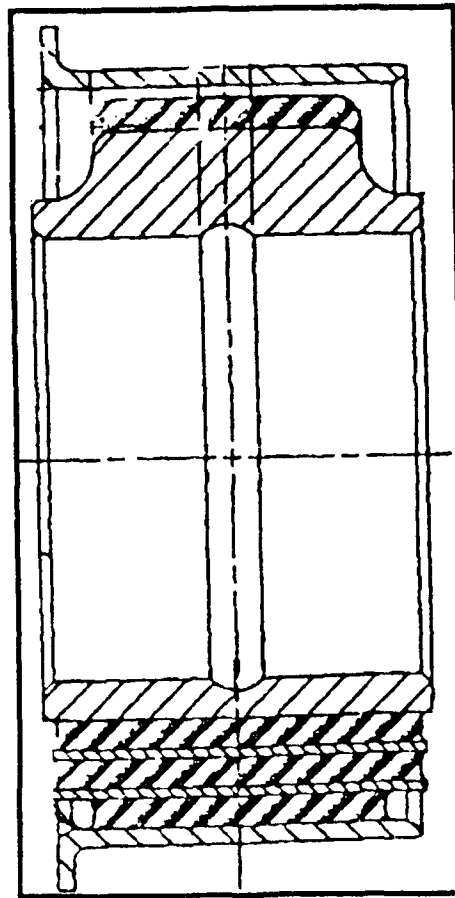
Figure 5.1-2 Schematic drawing showing the location of CT slices 1, 2, 3 and 4 on the drag brace bushing.

Computed tomography allows the observation of the interior of the new design without destructive sectioning that may relieve stresses. Figure 5.1-2 is a schematic of the elastomeric bushing which fits into the drag brace. The figure shows the location of the desired slices in the multilayered structure. Figure 5.1-3 shows the side view of this new bearing assembly design. Cylindrical section metal shims are embedded in the elastomer (to prevent it from ballooning out). CT slice locations were selected from digital radiographs of the drag brace. Figures 5.1-4, 5.1-5, 5.1-6, and 5.1-7 are CT slices taken at locations 1 through 4 respectively. The images show that the cylindrical metal shims in the elastomer have been distorted. Ideally they would appear as rectangular details in slices with this orientation. The characteristic "saddle" shape exhibited by the shims is a trait of a side load applied to this bushing which has left the material distorted. This information was supplied to the bearing manufacturer and will be used for future design changes.

Figure 5.1-3 Cross-section drawing of drag brace elastomeric bushing assembly with 0 and 90 degree cuts through Figure 5.1-2.

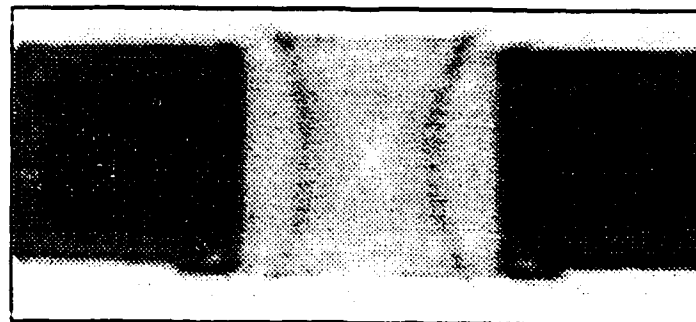
Figure 5.1-7 CT slice at location 4 on the drag brace bushing.

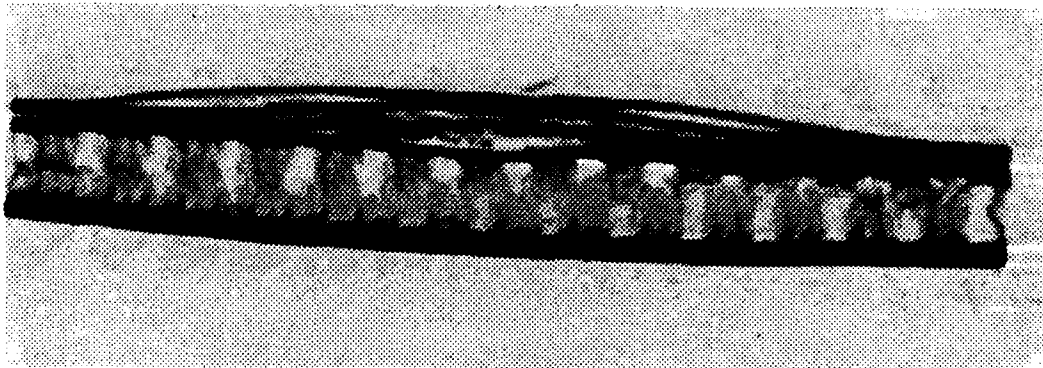
Figure 6.1-4 CT slice at location A with gray scale in image adjusted to observe the honeycomb.
